# Manhole Inspection Summary

Manhole # S29SS\_018MH

Insp Date: **5/15/07 9:27 AM**

**Location** Address: **555 SISSON ST**

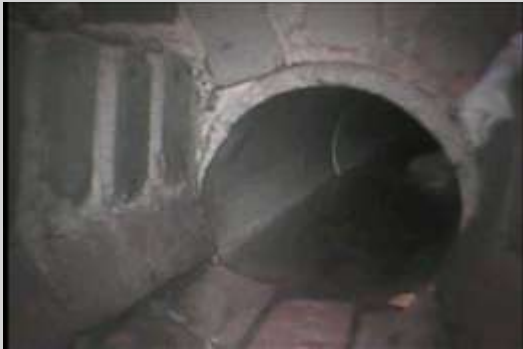
### 8 in. Circular Gravity Sewer Pipe Out @ 12 O'Clock

Rod and Bar (Angled)

Infiltration: **None** Pipe Seal Cond: **Unknown**
